SAFETY NOTICE

powerCON® TRUE1

Nr.: BDA 533 | Date: 20.12.2017 | Data subject to change without prior notice. ©2017 NEUTRIK®. ALL RIGHTS RESERVED. NEUTRIK® is a registered trademark.

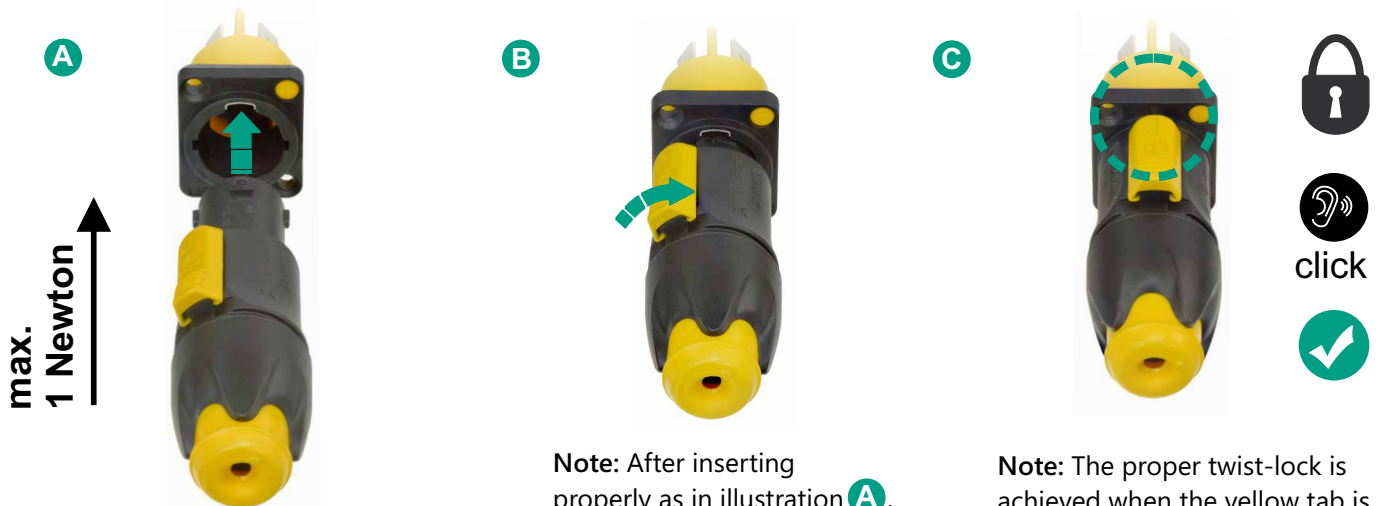
Note: When connecting, match the notch on the cable connector to the corresponding guide slot on the chassis.

Note: After inserting properly as in illustration **A**, twist the cable connector clockwise to lock.

Note: The proper twist-lock is achieved when the yellow tab is in the position shown in **C** and an audible «click» is heard.

To determine that the cable connector is inserted correctly, follow the use instructions and listen for the "click" when performing the twist-lock. Immediately unplug any connector that does not twist-lock correctly in place.

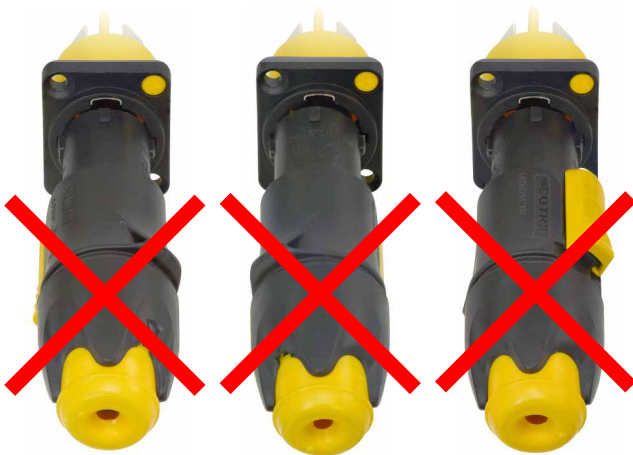
SAFETY WARNING

Incorrect insertion may cause electrical contact misalignment resulting in equipment malfunction and/or personal injury.

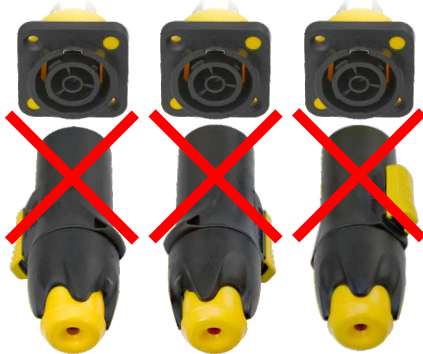
Note: When connecting, match the notch on the cable connector to the corresponding guide slot on the chassis.

max. 1 Newton

Note: After inserting properly as in illustration A, twist the cable connector clockwise to lock.

Note: The proper twist-lock is achieved when the yellow tab is in the position shown in C and an audible «click» is heard.

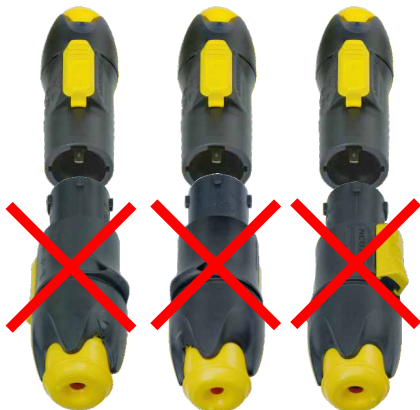
Note: When connecting, match the notch on the cable connector to the corresponding guide slot on the chassis.

max. 1 Newton

Note: After inserting properly as in illustration A, twist the cable connector clockwise to lock.

Note: The proper twist-lock is achieved when the yellow tab is in the position shown in C and an audible «click» is heard.
